Manhole Inspection Summary

Manhole # S17A1_016MH

Insp Date: **6/13/08 12:57 PM**

Location Address: **2608 wilmington av**

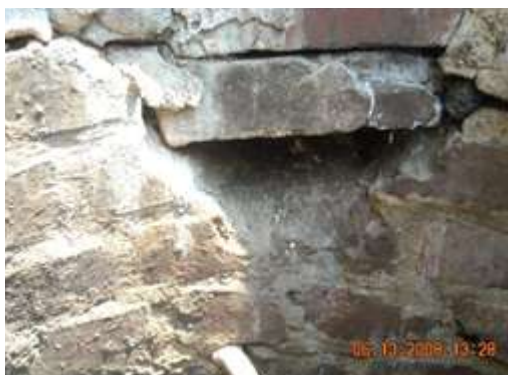
Defect 4

Condition: ☐ Sound ☐ Cracked ☐ Root Intrusion ☐ Loose Brick ☒ **Deteriorated**

deteriorated corbel

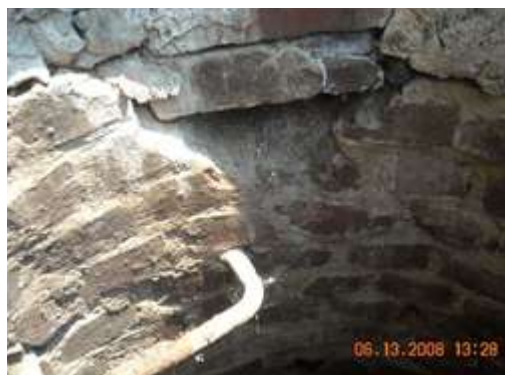
Defect 3

Infiltration: ☐ None ☐ Joint ☐ Cracks ☐ Mortar ☐ Roots ☒ **Wall**

infiltration @ corbel wall

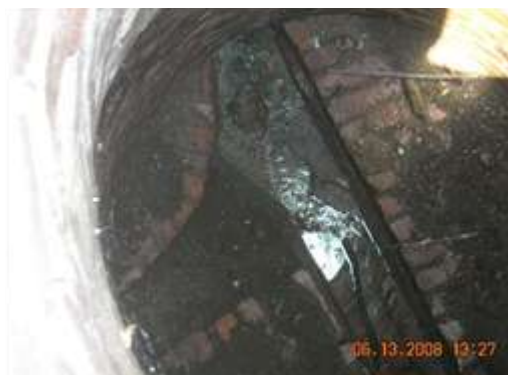
Defect 2

Condition: ☐ Sound ☐ Cracked ☐ Root Intrusion ☐ Deteriorated ☐ Leaks ☒ **Debris**

debris in channel

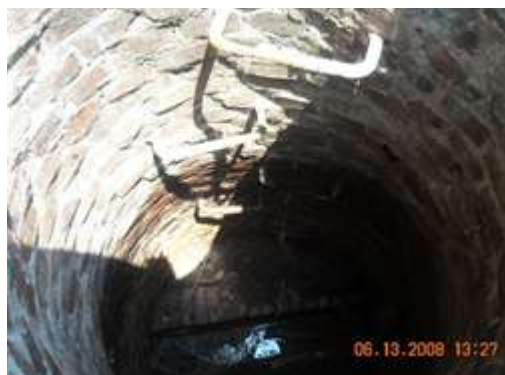
Defect 1

Steps Count: **4** Missing: **1** ☒ **Corroded**

corroded & missing steps

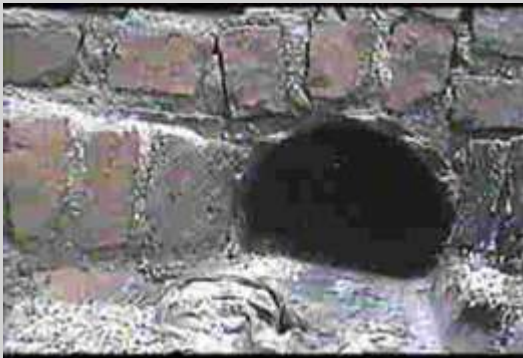
12 O'Clock Outflow

Pipe Height: **8.4** (in.) Rod and Bar (Angled)
Pipe Material: **Clay** ☐ Pipe Lined
Invert Depth: **9.95** (ft.) Flow Characteristics: **Slow**
Deposits: ☐ None ☒ **Mud** ☒ **Sludge** ☐ Debris ☐ Grease
Silt Depth: **2** (in.) Deposits Extent: **Light**
Infiltration: **None** Pipe Seal Cond: **Sound**

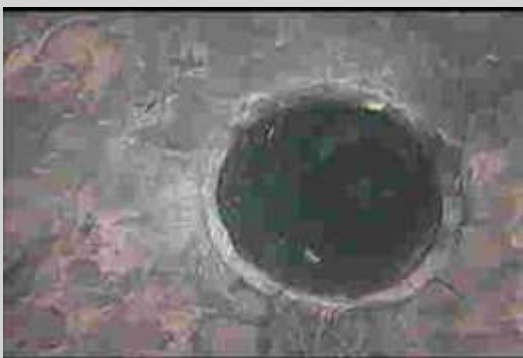
6 O'Clock Inflow

Pipe Height: **8.4** (in.) Rod and Bar (Angled)
Pipe Material: **Clay** ☐ Pipe Lined
Invert Depth: **8.70** (ft.) Flow Characteristics: **Slow**
Deposits: ☐ None ☒ **Mud** ☒ **Sludge** ☒ **Debris** ☐ Grease
Silt Depth: **5** (in.) Deposits Extent: **Heavy**
Infiltration: **None** Pipe Seal Cond: **Sound**

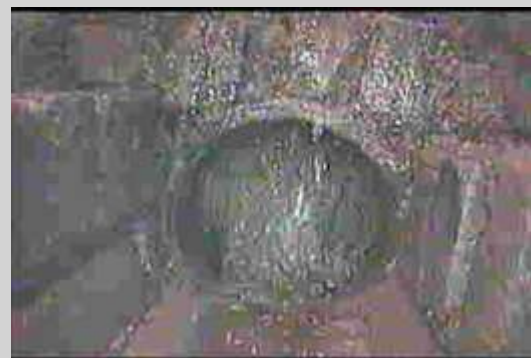
Drop In @ 6 OClock

Drop: **Outside** Rod and Bar
Angled: **Yes** Reading: **8.80** (ft.)
Inv Depth: **9.80** (ft.)
Drop Condition: **Partly Clogged**

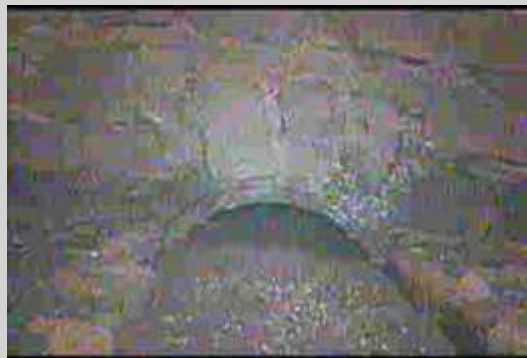
9 O'Clock Inflow

Connects To: **Stub connection / abandoned**
